Intel[®] Mobile Celeron[™] Processor Specification Update

Release Date: January 2000

Order Number: 244444-011

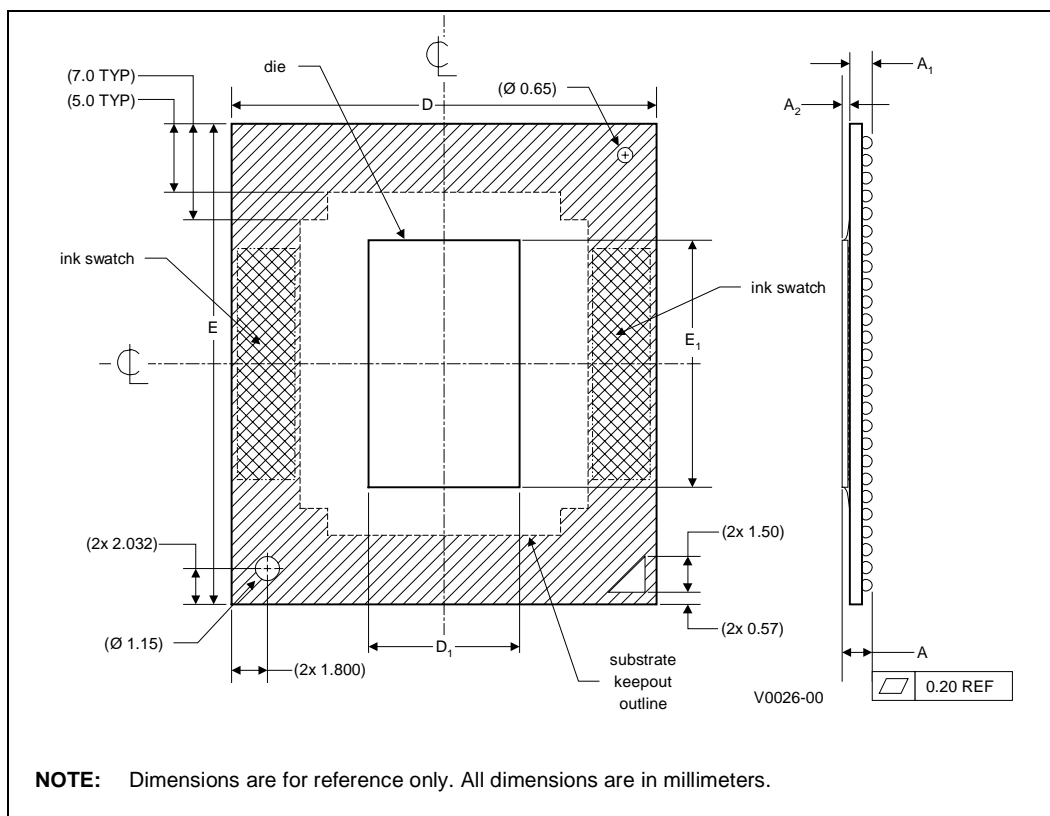
Figure 5.3. Surface-Mount BGA1 Package—Top and Side View

The following table and figures show the updated mechanical specifications for the BGA1 package, listed as Table 5.2, Figure 5.3 and 5.4, respectively, in the *Intel® Mobile Celeron™ Processor in BGA Package at 333 MHz, 300 MHz and 266 MHz* datasheet.

1. The number shown here is different from that in the 244444-004 version of this specification update. The maximum reference number is used.
